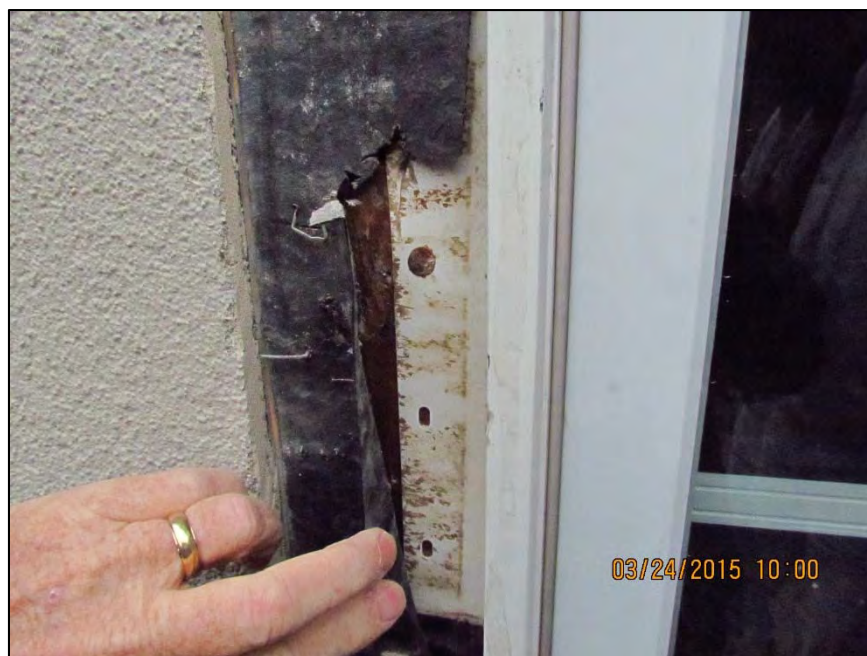
Figure 181

- e. The nailing flanges of the window frames were installed onto the wall sheathing.
  - f. The WRB is building felt. The WRB was installed over the nailing flanges at all sides of the windows (Figure 181), including the sill, creating a reverse lapped condition that can direct moisture behind the WRB (Figures 183 and 184). The sheathing below Buinewicz Specimen A was wet.

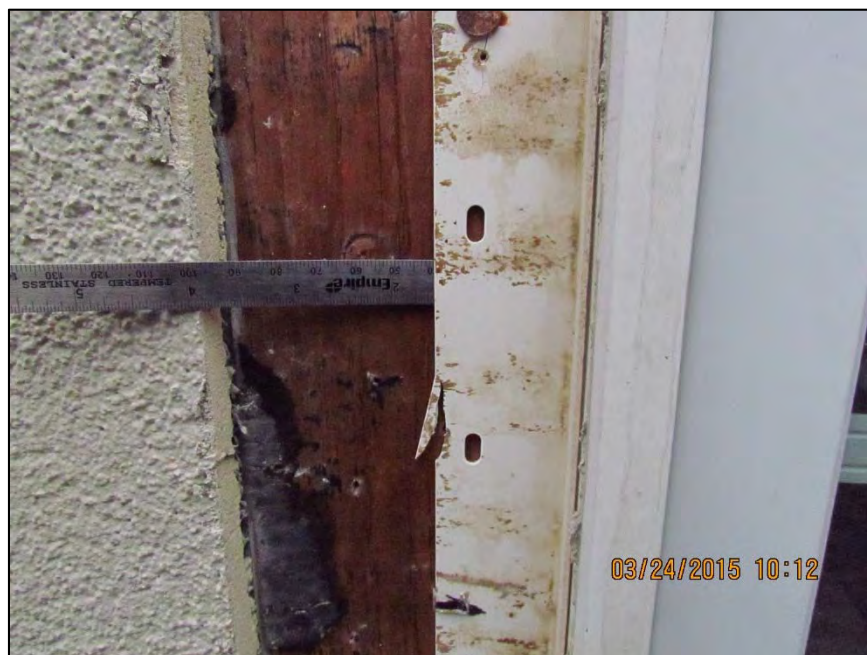
Figure 182

- g. No sealant was installed under the nailing flanges (Figures 182) or at the joint where the nailing flanges are inserted into the window frame (Figure 186) as required by the window installation instructions.<sup>162</sup> Also, no sealant was installed where required at the corner adhesive pads (Figure 186).<sup>163</sup> Further, no sealant was installed where it is required on the top outer surface of the frame at the head.<sup>164</sup>

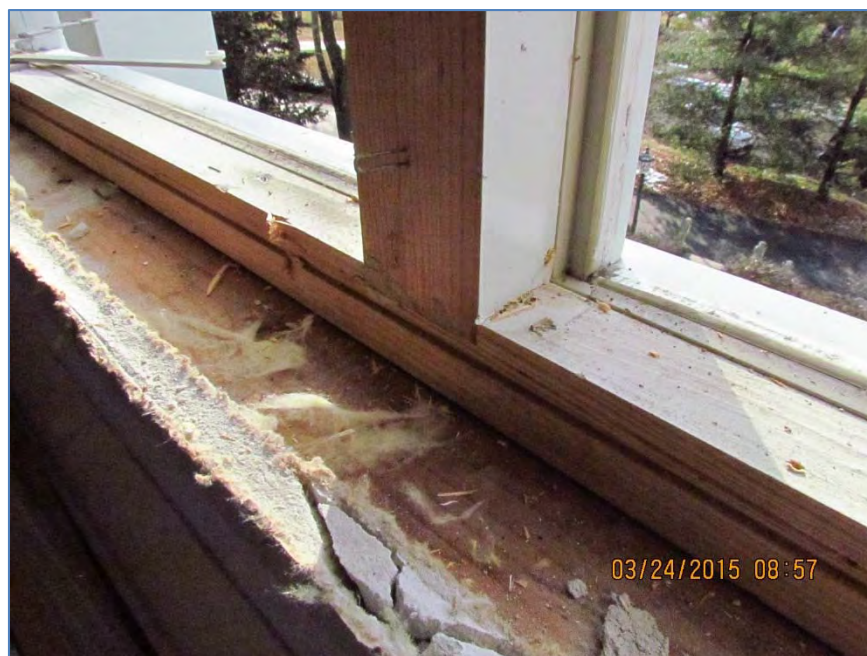
Figure 188

- a. No shims were used for installation of either of the windows (Figure 188).
- b. No WRB or flashing is wrapped into ether rough opening (Figures 188 and 191).

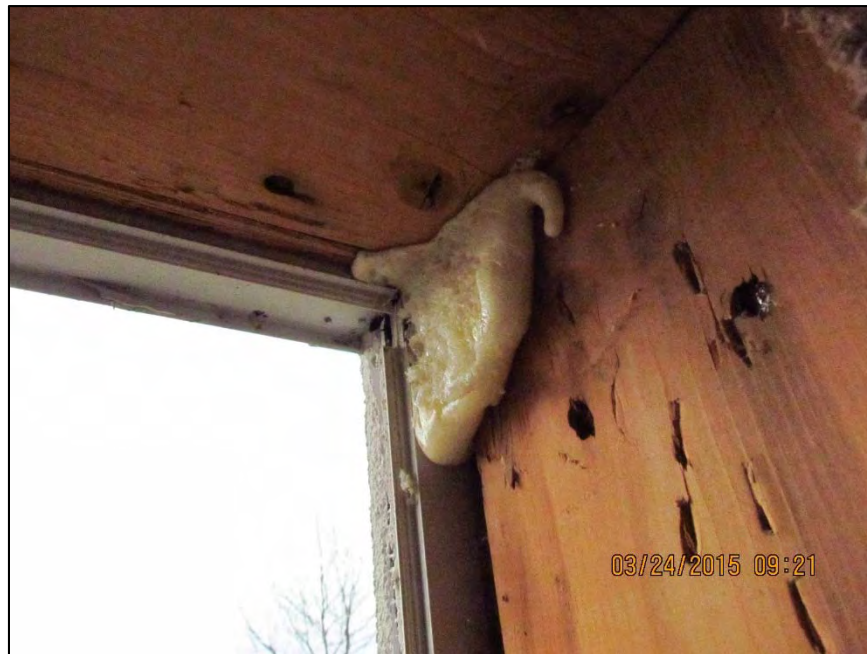
Figure 194

- e. At the twin casement window, the intersection of the nailing flanges at the bottom right corner of the window was improper; only a portion of the white corner pad is visible, and the adhesive side of flashing tape is visible at the balance of the corner (Figure 192). No sealant is visible on the inside of the corner as required by the window installation instructions.<sup>165</sup> Staining is present on the wall framing at this corner (Figure 193). Some staining is also visible at the top right corner of the opening (Figure 194).

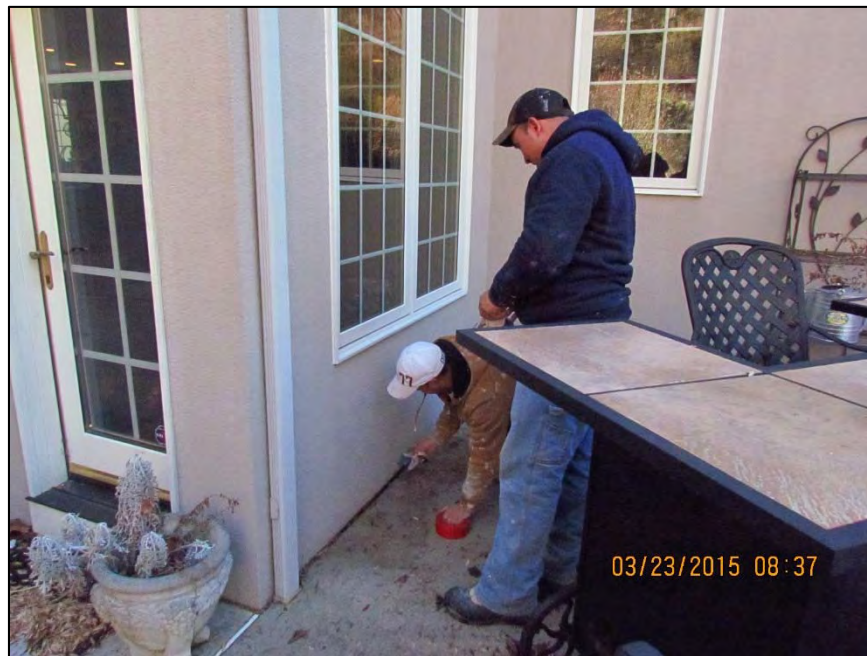
Figure 196

- a. Buinewicz IE 1 is located at the rear of the home. The cut was made at grade level below a window opening facing the southwest elevation (Figure 196). The window is one that has been previously replaced. The IE revealed that the stucco is installed on metal lath. The WRB is one layer of building felt (Figure 197). There is no wall flashing or stucco screed at the base of the wall. Moisture content of the sheathing at the top of the cut is acceptable, but moisture content of the sheathing at the base of the wall is elevated (Figure 198).

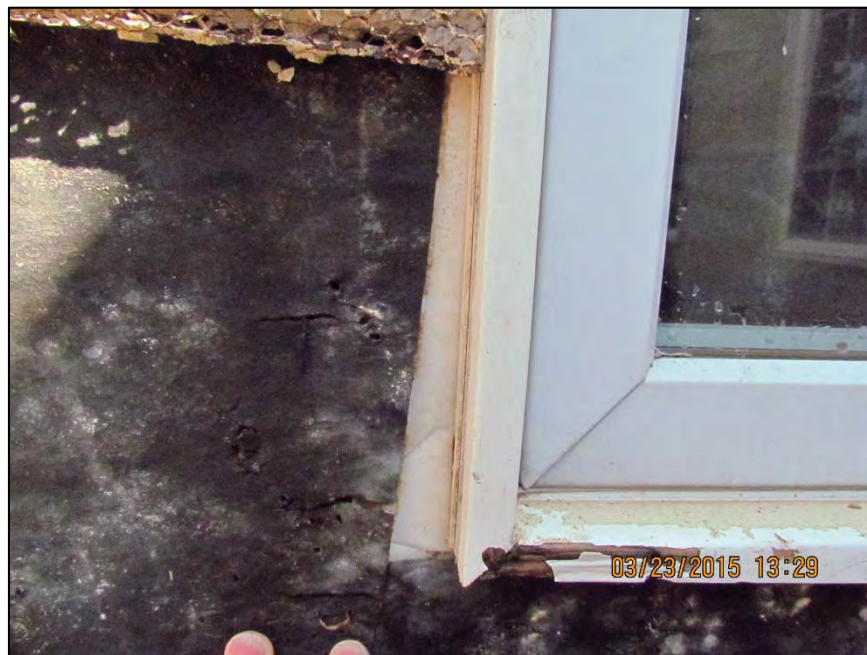
Figure 205

- building felt. The WRB was installed over the nailing flange of the window, including the sill, creating in a reverse lapped installation (Figure 205). As a result, water that enters along the side of the window because sealant was not installed may be able to flow down the outside of the nailing flange and behind the WRB upon reaching the bottom of the window. In addition, this water may be able to flow in behind the nailing flange because the flange was not sealed to the window frame as required, or to the wall, and as a result, this water can flow down and cause damage to the window frame and to the wall. The moisture content of the sheathing is moderately elevated (Figure 206).

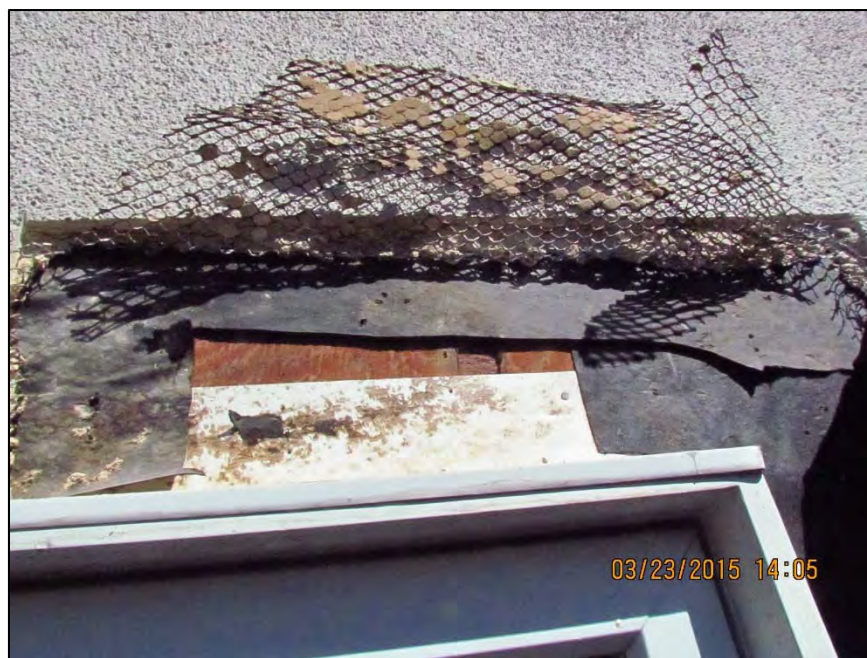
Figure 208

- d. Buinewicz IE 4 is located at the top corner of Buinewicz Specimen A (Figure 207). The IE revealed that the stucco is installed on metal lath. The WRB is building felt. The WRB was installed over the nailing flange of the window and a metal drip cap is installed over the nailing flange (Figure 208). The moisture content of the sheathing is normal.

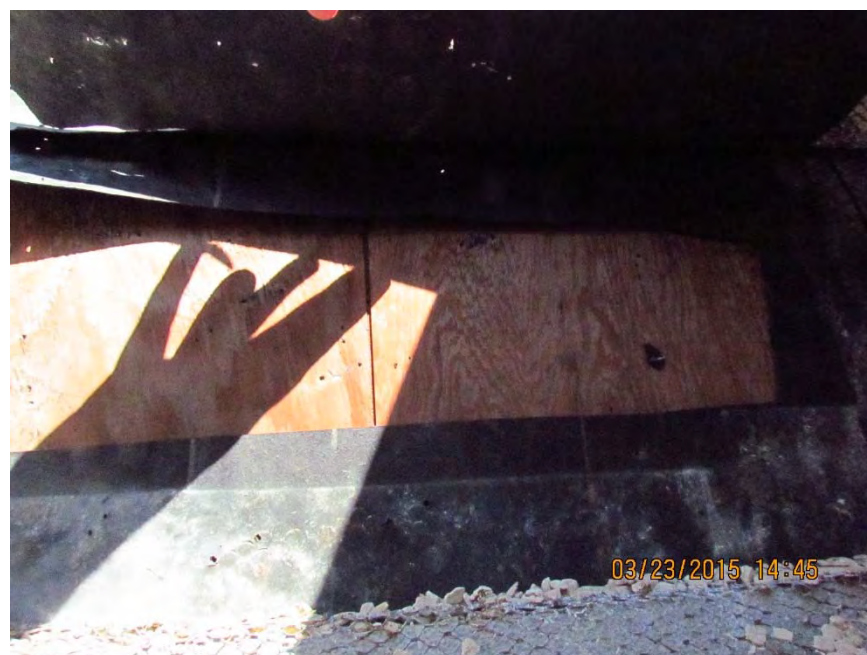
Figure 209

- e. Buinewicz IE 5 was an extension of IE 4. The cut was expanded so that the stucco was removed below the soffit adjacent to the roof-to-wall intersection (Figure 209). The moisture content of the sheathing is normal. However, even though this portion of the wall is well protected by the soffit, rusting stains appear in the metal lath and on the WRB indicating the presence of moisture (Figure 210).

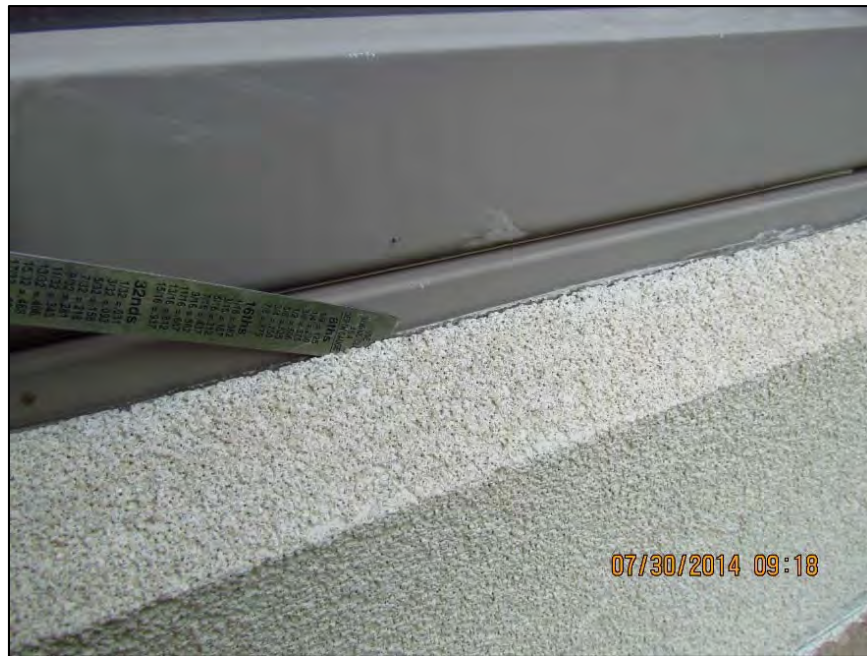
Figure 220

- tightly to the edge of the window and no gap was provided between the side of the window frame and the EIFS for sealant as required by the Kolbe installation instructions<sup>166</sup> (Figures 220 and 221). Instead, only a small thin sealant bead was applied over the surface of the joint (e.g. Figures 221 and 222), but the most vulnerable location, the sill, is generally unsealed (Figures 220 and 222). Some of the sealant has failed (Figures 221, and 223).

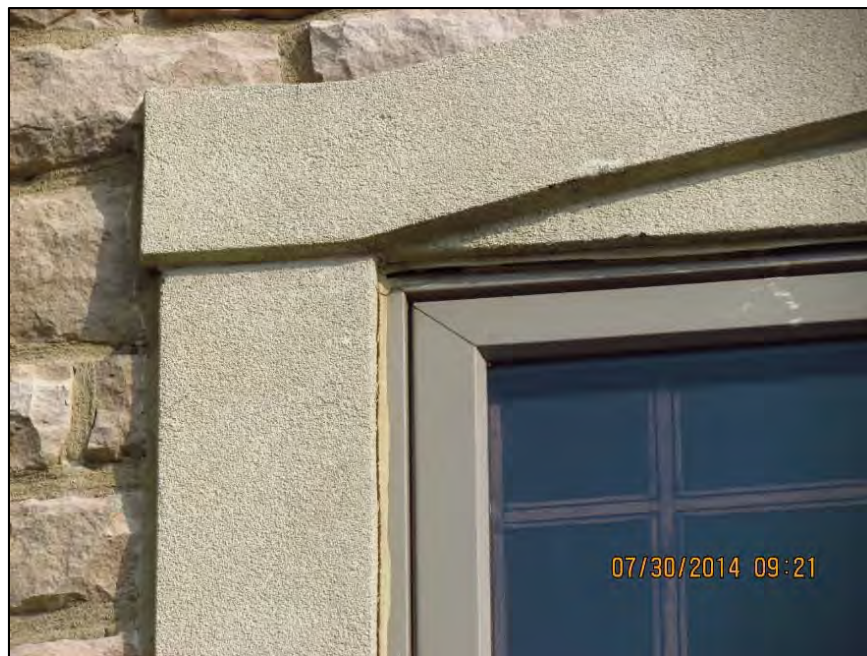
Figure 232

- e. At one window in a bedroom on the front elevation of the second floor (Figure 231), the bottom of one of the sashes had an elevated moisture reading at the time of the inspection and the sash-to-frame reveals at the top and bottom of the window sash are uneven (Figures 232 and 233). The exterior perimeter sealant on that side of the window has failed (Figure 232) and the head drip above the window is bent upward so

far that the top of the window frame is visible (Figures 232 and 234). These conditions and the uneven reveals suggest that the window frame may not have been properly installed and/or water entering around the frame has caused distress such that the sash binds to the frame and can no longer drain water as designed.

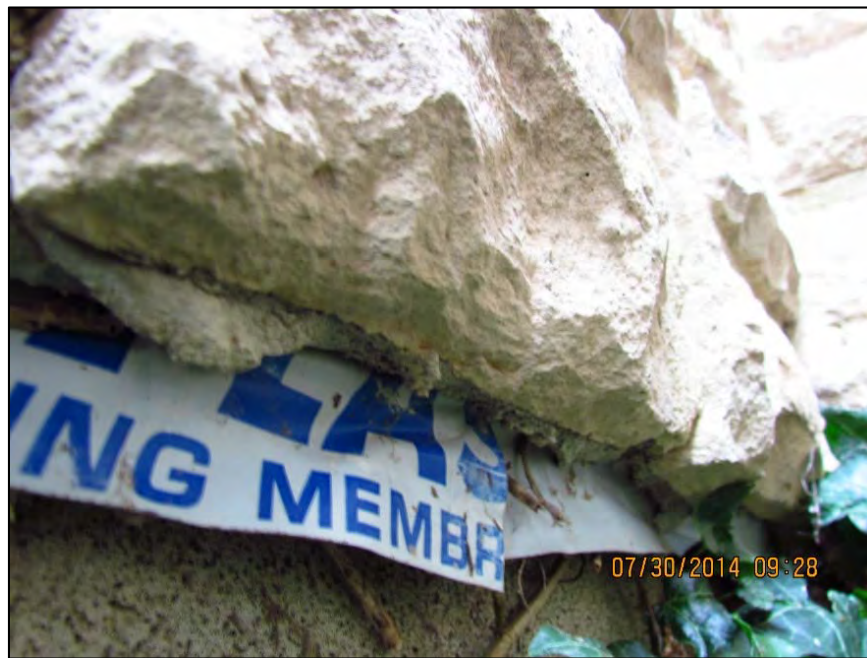
Figure 235

- a. Drainage provisions were incorporated into the exterior walls as can be seen by the end of the weather resistive barrier (WRB) that's visible at some areas near grade level (Figure 235). However, if the cultured stone is set in a full mortar bed as it appears, then the drainage capacity is minimal since the WRB has a smooth texture instead of a grooved texture. A full mortar bed on a smooth texture WRB does not provide the air space that's necessary to allow water drainage and instead, moisture is retained in direct contact with the WRB for prolonged periods. Since the WRB is designed to shed water instead of being in direct contact with water, the moisture can seep through the WRB and enter into the wall, and into the window openings.
- b. In many locations where roof kick-out flashing should be installed, none was used and

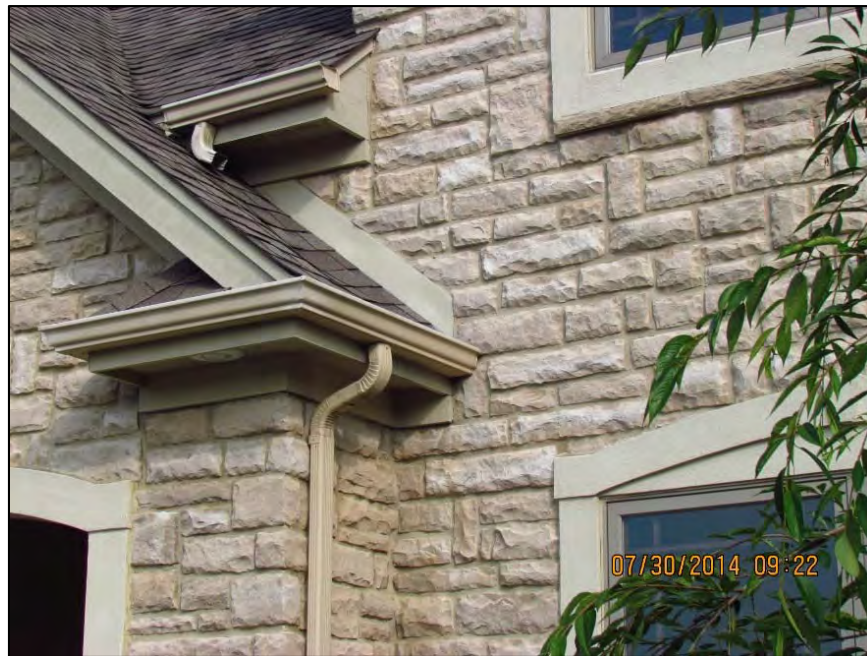
Figure 236

- some of these are located above window openings (e.g. Figure 236). Failure to provide kick-out flashing can allow water entry into the wall which then migrates downward, damaging the wall as well as the windows in the wall.
- c. Sealant is installed on the front elevation between the raised trim bands around the windows and the cultured stone, but the sealant has failed (Figures 237 and 238). The sealant failure can allow moisture to enter into the wall between the trim band and the cultured stone, which can then flow downward around the window frames below.

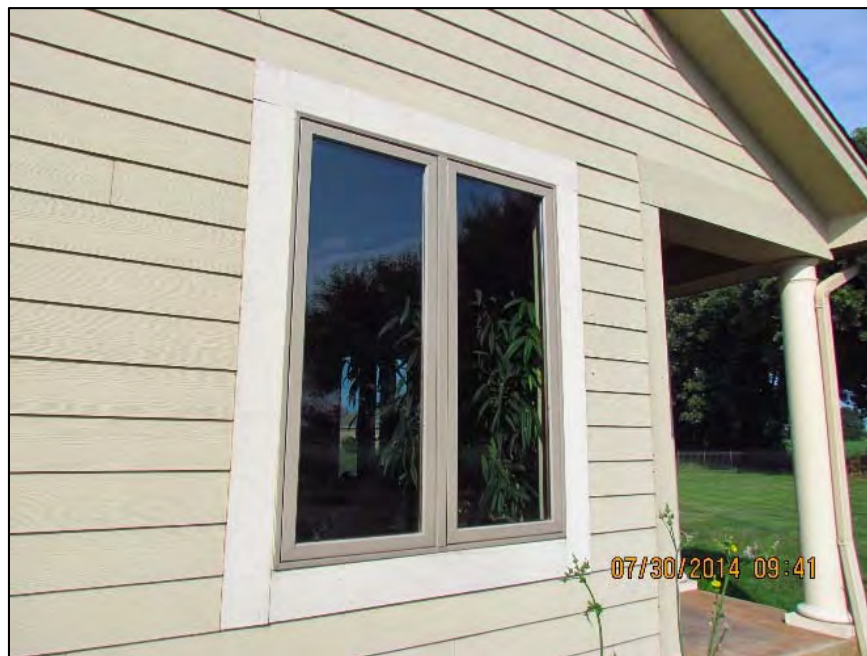
Figure 240

- a. Deller Specimen A is a twin casement window in the Dining Room on the southeast elevation of the first floor (Figure 239). Deller Specimen B is a twin casement window in Kitchen on the northeast elevation of the first floor (Figure 240). Pre-test examinations revealed that no water stains or material degradation was present on the window sashes, window frames, or on the wood framing or drywall around the window openings (e.g. Figures 241 and 242). No shims were visible at the sills of Deller Specimen A. Neither of the windows were installed plumb, level and square<sup>167</sup>.
- b. Appendix H to the Exponent report states that Arcadia performed the air testing in

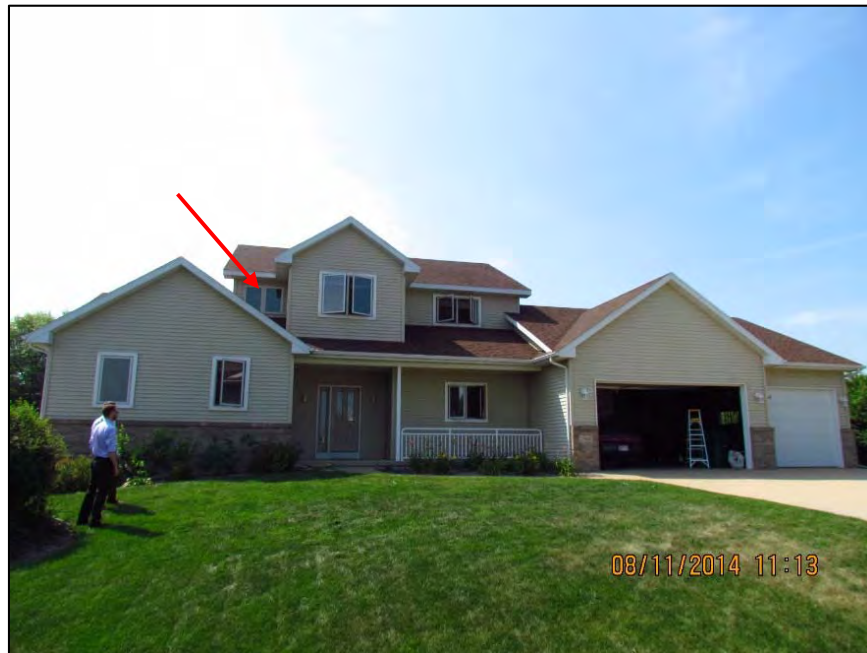
Figure 249

- 8.5.2 The Lohr residence is a two-story single family home over a basement. A covered entry faces the street on the north elevation (Figure 249). The home is located just south of an open area (Figure 250). Neighboring homes are located on either side. The home is constructed with wood framed walls. The roofing is asphalt shingles and has some gutters and downspouts. Conventional roof overhangs offer some protection to openings immediately below the roof line but far less to those on the lower levels, and the gable end walls on the east and west elevations provide very little protection to openings on those walls. The exterior wall cladding is primarily vinyl lap siding on the north (Figure 249), west (Figure 251), south (Figure 250), and east (Figure 253) elevations. There are also small areas of brick cladding on the north elevation (Figure 249).

8.5.4 On October 2, 2014, Exponent removed a window on the front elevation for examination (Arrow at Figure 249). This is an operable casement window, but because of its location in a stairwell, the window is only accessible from the interior by use of an extension ladder. The window sashes are original 2000 vintage. GCI's noted the following:

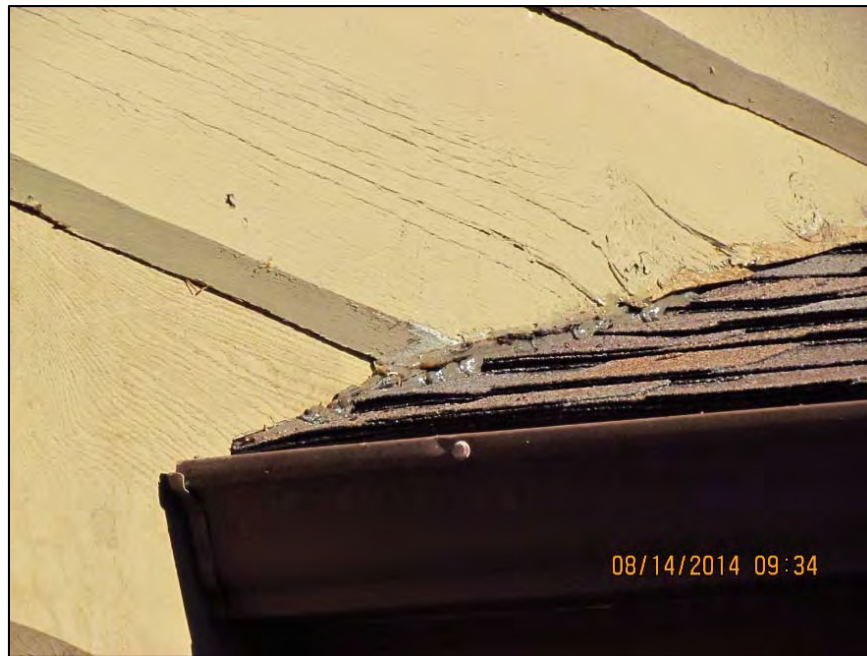
Figure 309

- a. No flashing is visible at roof-to-wall terminations. Instead, the siding is caulked to the roofing shingles (Figures 309 and 310).
- b. No kick-out flashing is installed at the bottom end of roof-to-wall terminations (Figures 309 and 310).
- c. Unlike the Kolbe windows, the non-Kolbe window and patio door on the rear elevation were installed with raised trim surrounds that was clad with aluminum (Figure 311) and the cladding trim was fully sealed to the surrounding wall siding.
